Tomographic Imaging of the Excavation Damage Zone for an Underground Disposal Facility

Areas: Geological Storage, Civil
Client: Posiva Oy
Location: Olkiluoto, Finland.

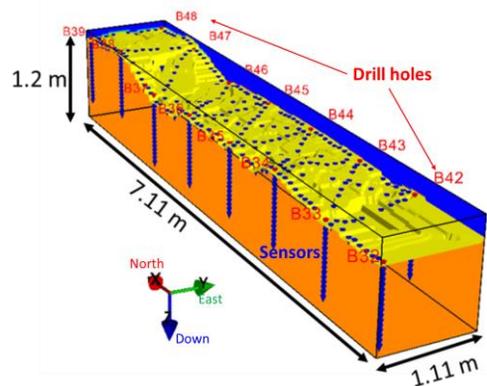
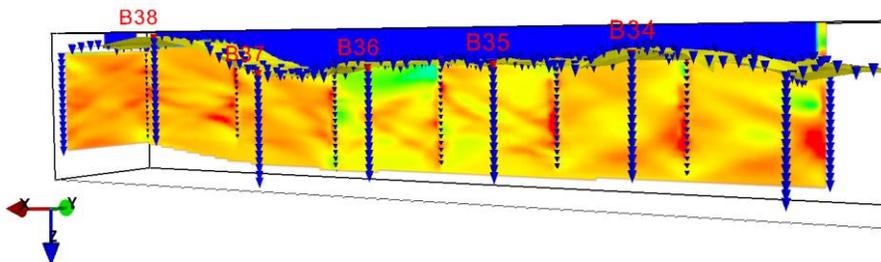
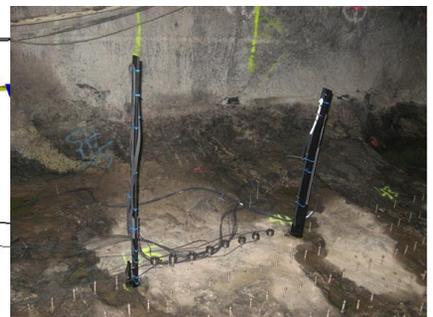
The results showed that the P-wave velocity varies between $4,800 \text{ m}\cdot\text{s}^{-1}$ and $6,500 \text{ m}\cdot\text{s}^{-1}$, with higher velocities at the northern end of the EDZ field. A general trend of increasing velocities with depth was observed, with lower velocities confined to the top 0.5 m associated with a higher degree of fracturing or damage. The modest variation of velocity with direction also indicates weak anisotropy. The higher velocities in the NE-SW direction may suggest oriented fracturing developed in its normal direction NW-SE. Some low velocity anomalies near a number of drill-holes can also be observed in the tomographic image and may be associated with local damage around the drill-holes. The combination of tomography surveys with other geophysical measurements can characterise the rock deformation in the EDZ and provides better evaluation of the long-term safety and integrity of the rock mass around engineered openings in the nuclear disposal facility.

Ultrasonic tomography is an active imaging technique that utilises the ultrasound to image the velocity variation beneath the excavation surface. This can provide a map of damaging through the structure based on the spatial variation of velocity images.
